Manhole Inspection Summary

Manhole # S45C2_029MH

Record Plat: **45C2** Node: **029** Status: **Found**

Location Address: **Pennington Ave.**

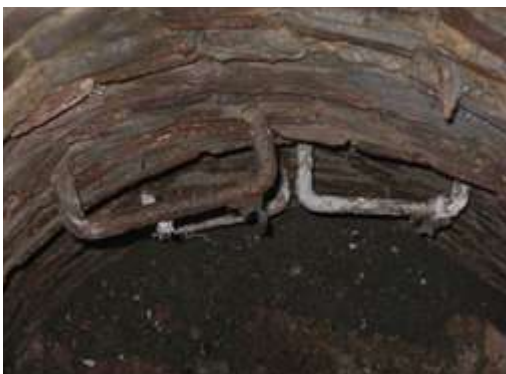
Steps

Count: **3** Missing: **0** ☐ Corroded

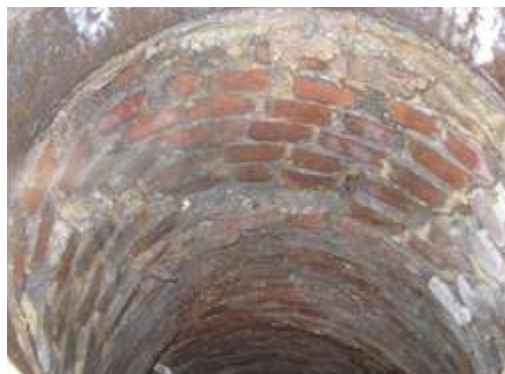
Defect 1

Condition: ☐ Sound ☒ **Cracked** ☐ Root Intrusion ☐ Loose Brick ☐ Deteriorated

Cracked

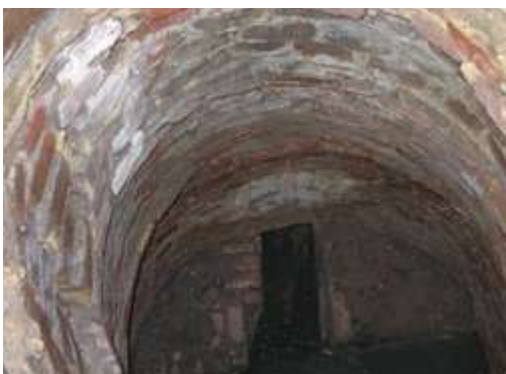
Defect 2

Infiltration: ☐ None ☒ **Joint** ☒ **Cracks** ☒ **Mortar** ☐ Roots ☒ **Wall**

Infiltration

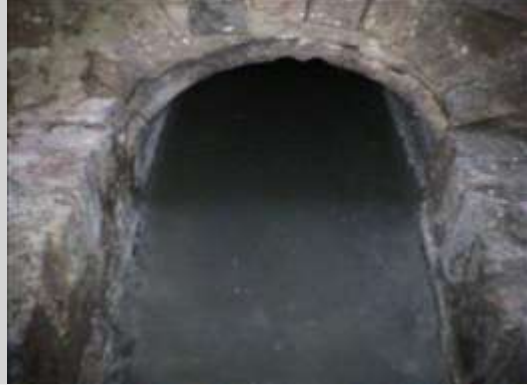
12 O'Clock Outflow

12 in. Circular Gravity Sewer
Pipe Out @ 12 O'Clock

Pipe Height: **16.8** (in.) Rod and Bar (Angled)
Pipe Material: **Clay** ☐ Pipe Lined
Invert Depth: **9.95** (ft.) Flow Characteristics: **Slow**
Deposits: ☒ None ☐ Mud ☐ Sludge ☐ Debris ☐ Grease
Silt Depth: (in.) Deposits Extent:
Infiltration: **None** Pipe Seal Cond: **Sound**

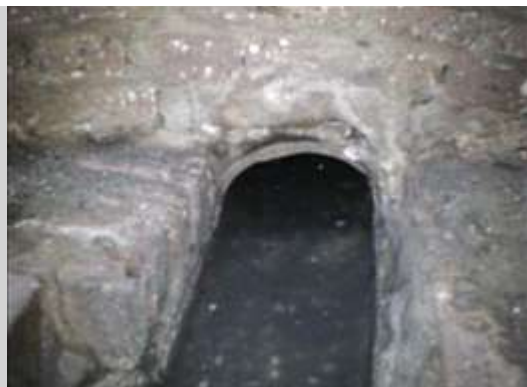
3 O'Clock Inflow

8 in. Circular Gravity Sewer
Pipe In @ 3 O'Clock

Pipe Height: **8.4** (in.) Rod and Bar (Angled)
Pipe Material: **Clay** ☐ Pipe Lined
Invert Depth: **9.77** (ft.) Flow Characteristics: **Slow**
Deposits: ☒ None ☐ Mud ☐ Sludge ☐ Debris ☐ Grease
Silt Depth: (in.) Deposits Extent:
Infiltration: **None** Pipe Seal Cond: **Sound**

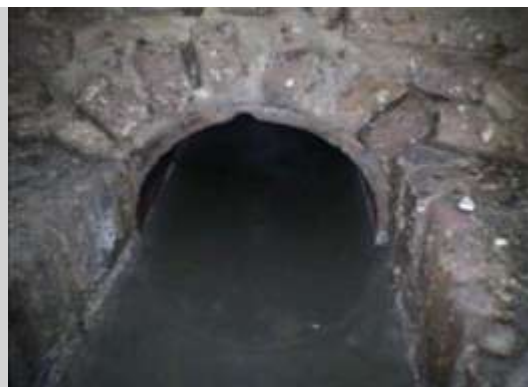
6 O'Clock Inflow

12 in. Circular Gravity Sewer
Pipe In @ 6 O'Clock

Pipe Height: **13.2** (in.) Rod and Bar (Angled)

Infiltration: **None** Pipe Seal Cond: **Sound**
